**OBSERVATIONS OF FATIGUE CRACK
INITIATION AND DAMAGE GROWTH IN
NOTCHED TITANIUM MATRIX COMPOSITES**

R. A. Naik and W. S. Johnson

January 1990

National Aeronautics and
Space Administration

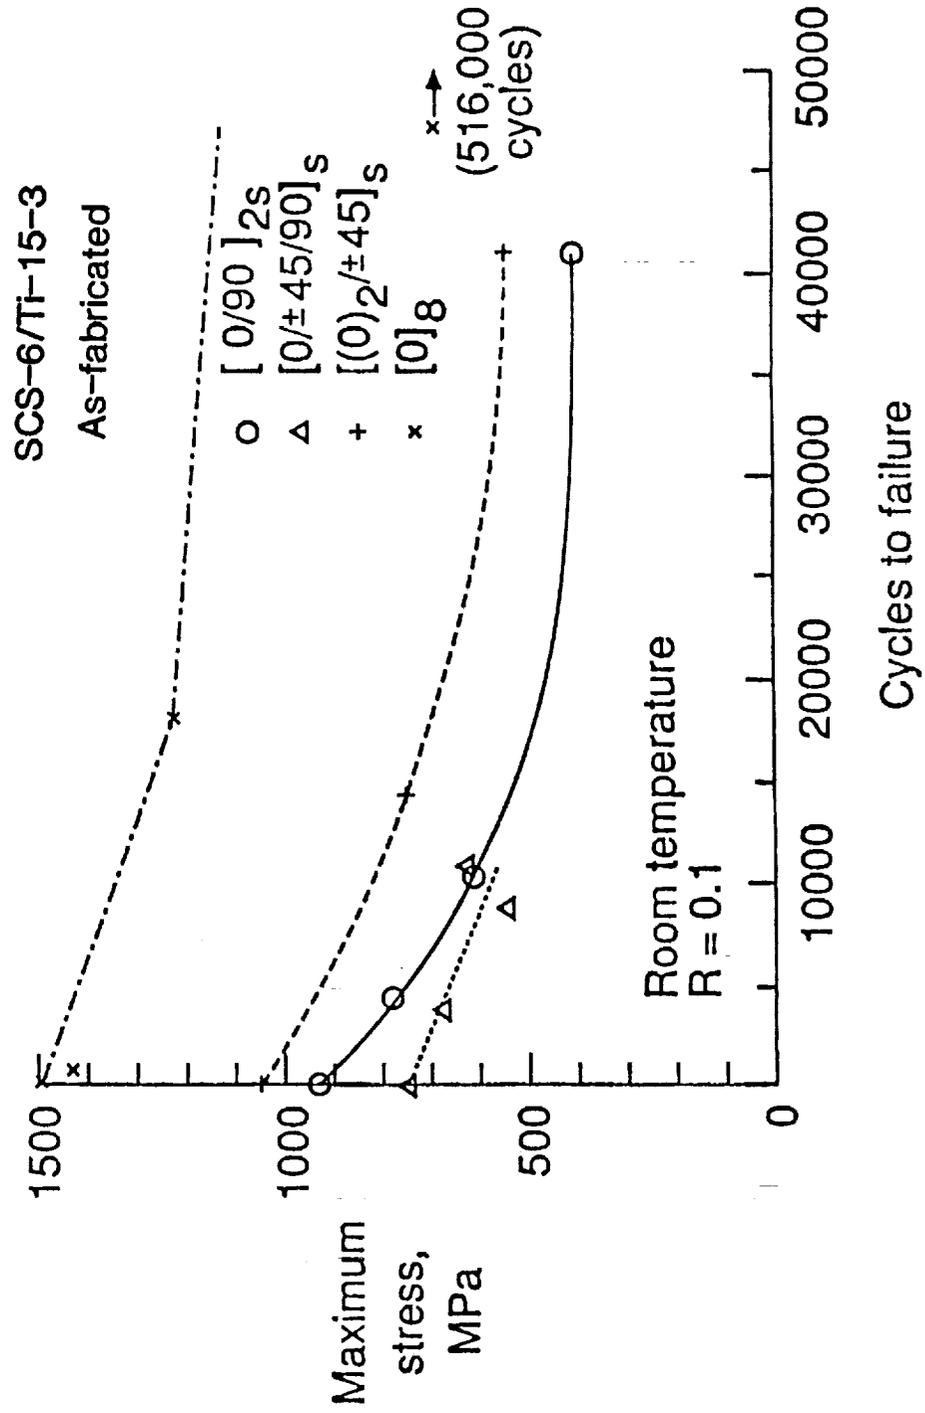
Figure 1.- S-N curves for SCS-6/Ti-15-3 laminates [1].

Data for the applied maximum cyclic stress versus the number of load cycles to failure was presented for four lay-ups of SCS-6/Ti-15-3 in reference [1]. The room temperature data for the as-fabricated specimens is shown in Figure 1. All of the lay-ups, $[0]_8$, $[0_2/\pm 45]_2$, $[0/\pm 45/90]_2$, and $[0/90]_{2s}$, contain 0° plies. Since the fiber/matrix interfaces in the off-axis plies fail after a very few cycles [1], the 0° plies carry most of the load during the fatigue life of these specimens. Because of these interface failures in the off-axis plies, those laminates containing off-axis plies experience a significant reduction in overall stiffness in the first few cycles. After the first few cycles, however, the stiffness remains constant for the remainder of the fatigue life until just prior to specimen failure. The strain range is, therefore, also constant with the applied constant loading after the first few cycles. This strain range can be multiplied by the fiber modulus of 400 GPa to yield the cyclic stress in the 0° fiber during essentially the entire fatigue life [1]. When the cyclic stress in the 0° fibers was calculated for each data point in Figure 1 and plotted against the number of cycles to fatigue failure, the data from the four different laminates collapsed into a narrow band, as shown in Figure 2. This suggests that the fatigue life of a given laminate is a function of the stress in the 0° fiber. This is reasonable since none of the laminates tested will fail until the 0° plies fail. The cycles to failure as a function of the overall laminate strain range is also shown in

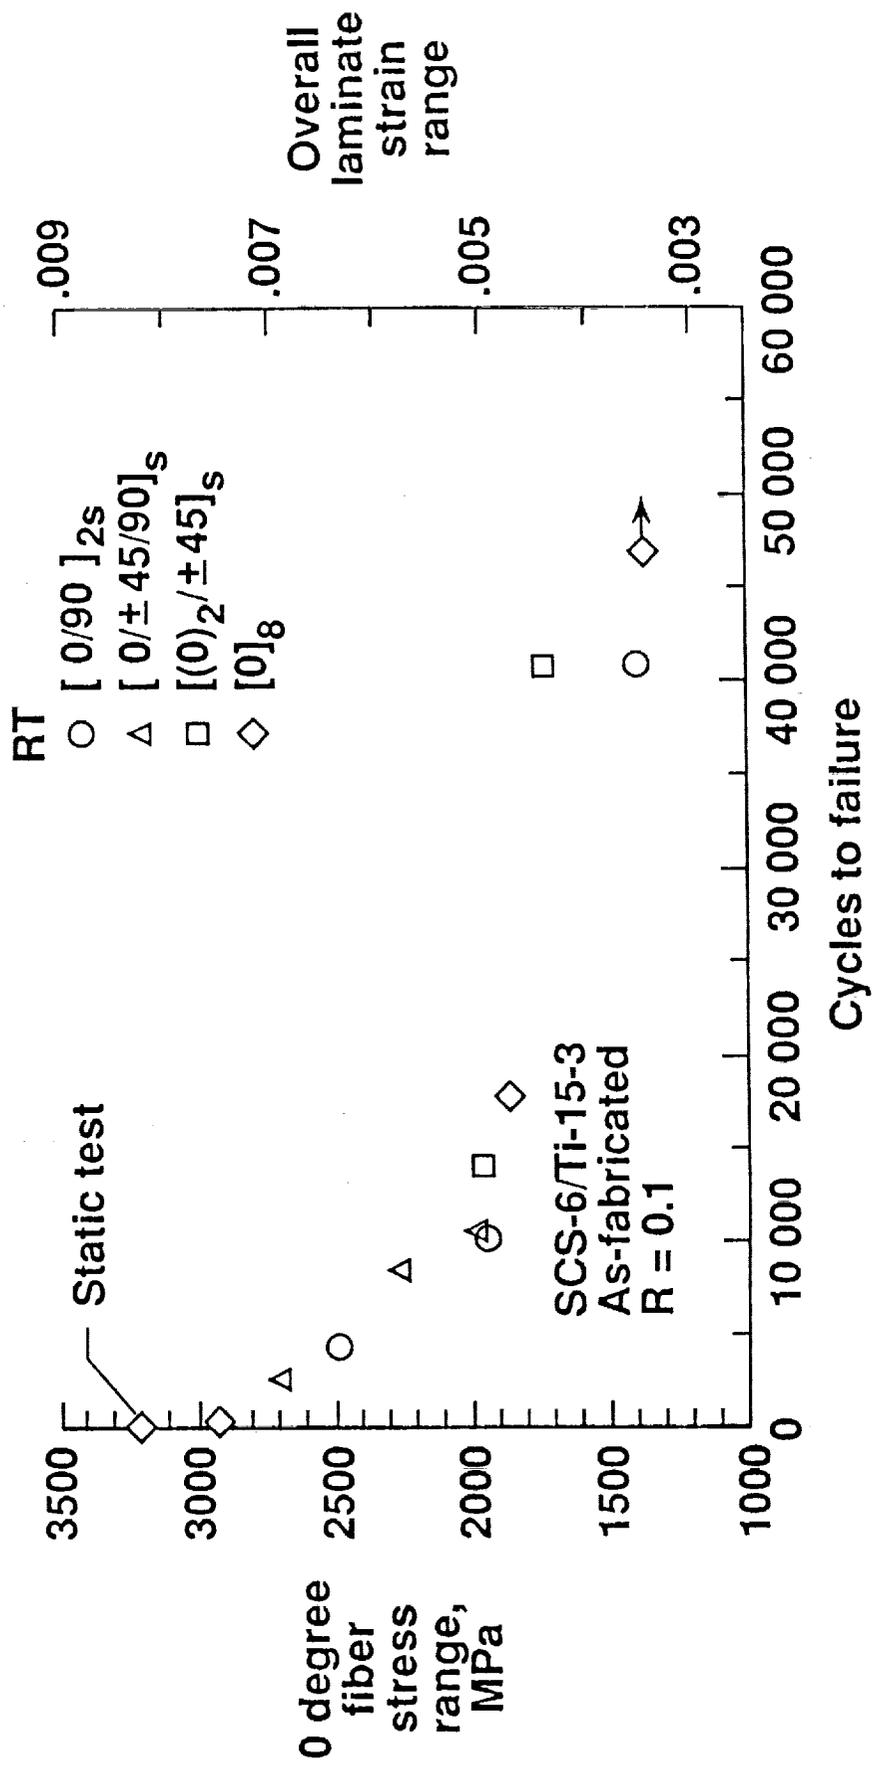
Figure 2.- Cyclic stress range in 0° fiber and laminate strain range versus number of cycles to laminate failure [1].

figure 2. This data, in terms of the strain range, will be used later to predict local damage using a strain range criterion.

Both the ASF and aged specimens were tested in the double edge notched configuration. As mentioned, the $[0]_8$ ASF specimens were tested using an incremental stress range approach in which the specimen was fatigued at each stress range for 50,000 cycles (see Table 1). The objective of using such an incremental approach was to determine the stress range at which damage initiation occurred. It was important to make a reasonable prediction of the damage initiation stress before starting the test. The data in figure 2 for unnotched SCS-6/Ti-15-3 laminates was used together with the computed notch stress concentration factor to make such a prediction. According to the data in figure 2, the unnotched $[0]_8$ laminate

has an endurance strain range (at 50,000 cycles) of 0.0033. Using the computed stress concentration factor of 5.61 for the notched laminate (see Appendix), it can be shown, using a simple rule of mixtures analysis, that an applied maximum cyclic stress of 122 MPa would result in local damage initiation after 50,000 cycles for the notched laminate. For the ASF specimen, tested using the incremental stress range approach, damage initiation was observed after 25,000 cycles at a maximum cyclic stress of 122 MPa (see Table 1). Also, a second ASF specimen (see Table 1) was tested using the incremental stress range approach starting at a cyclic maximum stress of 250 MPa. Using the rule of mixtures and the computed stress concentration of 5.61 this will lead to a local strain range of 0.006 at the notch tip. According to the data in figure 2, local damage initiation would occur at this strain range after 5000 cycles. Damage initiated in this specimen after 7,500 cycles at a maximum cyclic stress of 250 MPa. The same incremental stress range approach was continued after damage initiation in order to study damage growth in these specimens. In contrast to the test procedure for the ASF specimens, the aged specimen was tested at a constant stress range the entire test in order to study fatigue damage growth.

The most significant finding in the above tests, on both the ASF and aged $[0]_8$ notched specimens, was that the cracks grew only in the matrix leaving the fibers intact. The test stress levels were chosen by considering the stress concentration of the notch and the strain range at which fatigue failure had been observed for the unnotched laminate (Figure 2). It was expected that the matrix cracking would precede fiber breakage only by a short distance. The lack of fiber failure suggests that the multiple matrix cracking and/or fiber/matrix debonding led to a reduction of the notch stress concentration to a level that was below the fatigue endurance limit of 1320 MPa for the SCS-6 fibers (see Figure 2).

The limiting fiber stress range is approximately 1320 MPa (see Figure 2). This corresponds to a strain range in the fiber, and also in the composite, of 0.0033. Thus, the strain range in the [0/90/0] composite should be at least 0.0033 in order to break fibers. Using a composite longitudinal modulus of 156 GPa [2], the maximum cyclic stress in the composite should be at least 572 MPa in order to break fibers. Assuming the matrix carries its share of the load, the stress concentration would, therefore, have to be below 2.66 (computed as the ratio $(572 \text{ MPa}/215 \text{ MPa})$) in order to not fatigue the fibers, next to the hole, beyond their fatigue limit. It does not seem unreasonable to think that local fiber/matrix debonding at the hole could lower the stress concentration from the original 3.62 to below 2.66. These results indicate that if the stress concentration is reduced (eg. by fiber/matrix debonding), a much higher laminate stress is required before the 0° fibers and, subsequently, the composite will fail.

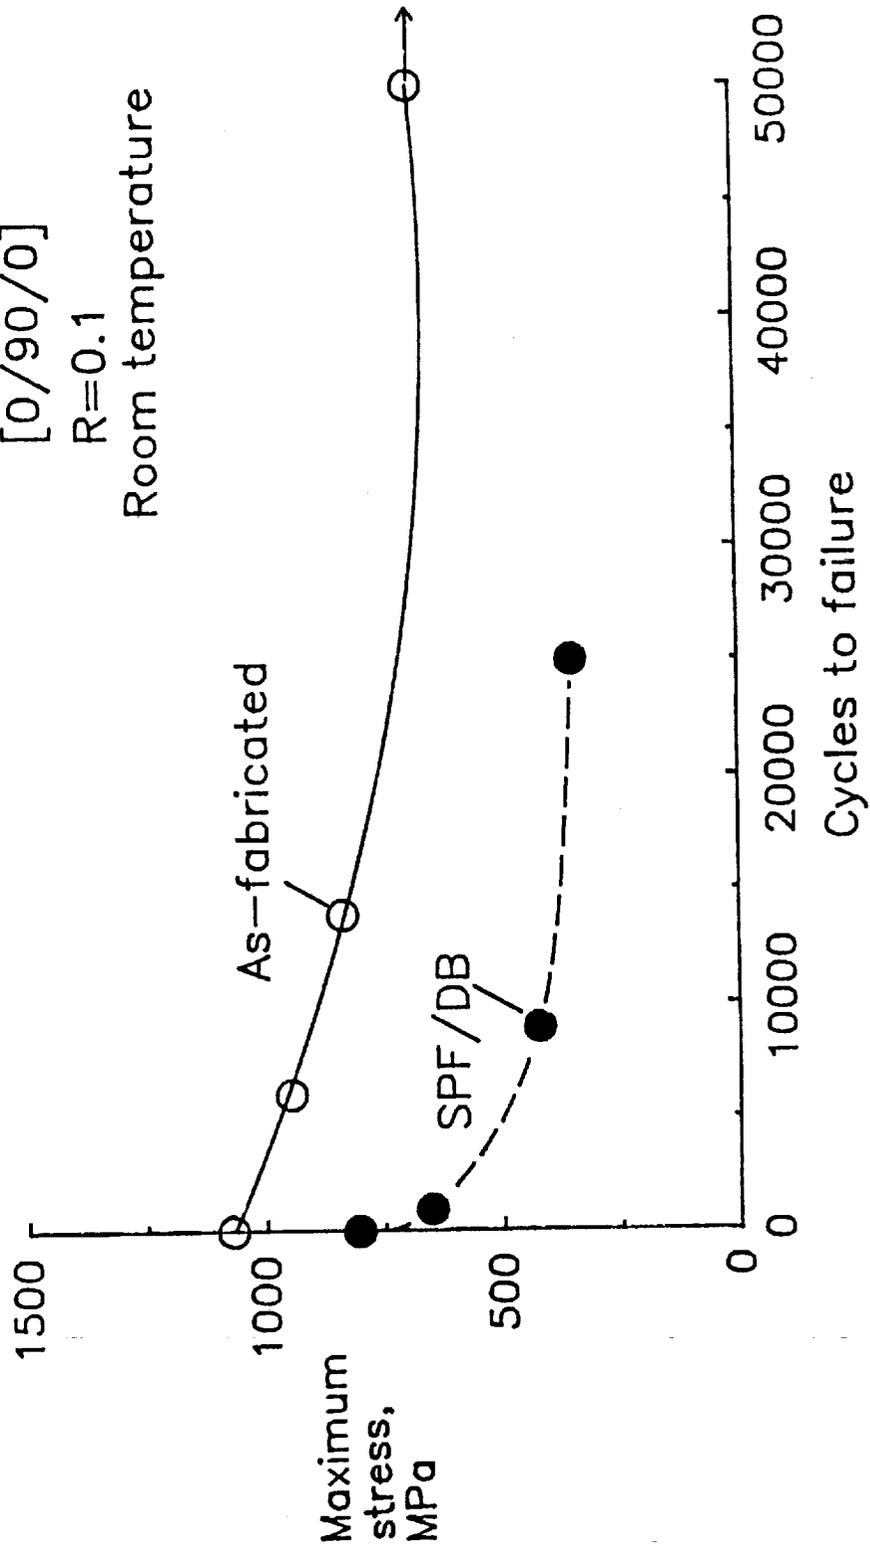
Figure 3.- S-N curves for ASF and SPF/DB [0/90/0] SCS-6/Ti-15-3

laminates [2].

MPa using a stress concentration factor of 3.62 at the hole. From Figure 3 this stress level should have resulted in local damage in 17,000 cycles for the ASF specimen and 100 cycles for the SPF/DB. For the ASF specimen tested damage initiation was observed at 50,000 cycles and at 40,000 cycles for the SPF/DB specimen.

Figure 3 shows that the 320 MPa stress is well below the fatigue limit for the ASF laminate. Even if the matrix were completely cracked in the net section and the fibers carried all the load, the stress in the 0° fibers would be 865 MPa ($320 \text{ MPa}/0.37$, the fiber volume fraction). Figure 2 shows that this value of fiber stress is well below the fatigue limit for the fibers.

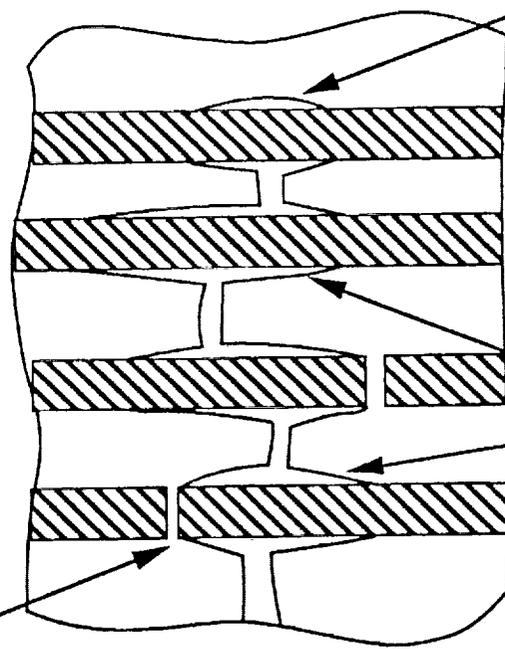
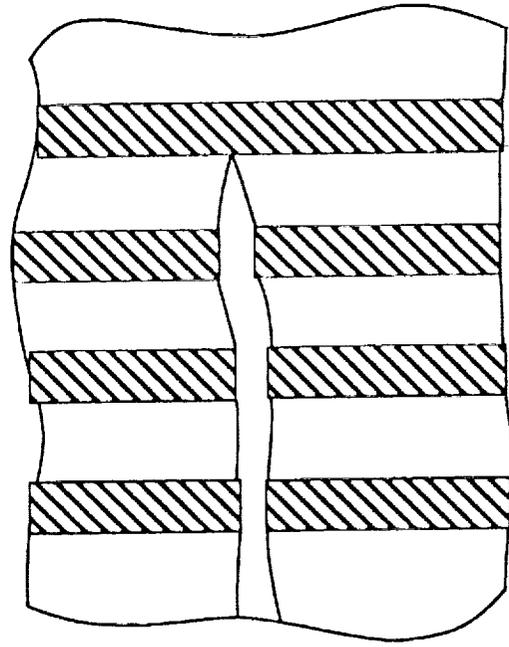
ASF

Fiber failure behind
crack tip

Fiber/matrix
debonding

Crack-tip
blunting

SPF/DB

Figure 4.- Failure mechanisms in 0° ply for ASF and SPF/DB [0/90/0] laminates [2].

Naik, Johnson and Pollock [2] have shown that the mechanical behavior of SCS-6/Ti-15-3 [0/90/0] laminate can be significantly effected by exposure to the high temperature cycle (described later) associated with a superplastic forming/diffusion bonding (SPF/DB) process. Figure 3 shows an S-N curve for the as-fabricated (ASF) and the SPF/DB materials. The data shows that the SPF/DB material experienced a 25 percent drop in static strength and a significant reduction in fatigue resistance. This degradation in mechanical behavior was attributed to a change in failure mode caused by an increase in the fiber/matrix interface strength and an increase in the thermal residual stresses in the matrix surrounding the fiber. Figure 4 shows a schematic of the failure processes described in [2]. In the ASF case, the interface was weak and the residual stresses were lower, thus, allowing the matrix crack to debond along the length of the fiber and then continue on the other side of the fiber without breaking the fiber. In the SPF/DB case, the interface strength was strong enough, coupled with the higher thermal residual stresses [2], to cause the matrix crack to propagate through the fibers. As described in [2], it can be shown by a shear lag analysis [3] that the stress in the first unbroken fiber in the crack path is 35 percent higher for the SPF/DB failure mode (figure 4), thus explaining the resulting change in mechanical behavior.

Figure 11 shows a photograph of the multiple crack pattern that was observed in the center-hole $[0/90]_{2s}$ specimen. The cracks are the light streaks seen in the photograph. This type of damage was also observed by Harmon and Saff [9] for center hole specimens of SCS-6/Ti-15-3. In order to study the internal damage, the specimen shown in figure 11 was sectioned and polished. Figure 12 shows micrographs of the damage in the 0° ply. Figure 12(a) shows cracks in the matrix but no fiber failure. Figure 12(b) shows a close-up view of one of these matrix cracks and the region around it. There is evidence of fiber/matrix debonding along the first fiber next to the hole and also on both sides of the matrix cracks. This corresponds to the ASF failure mechanism shown in figure 4.

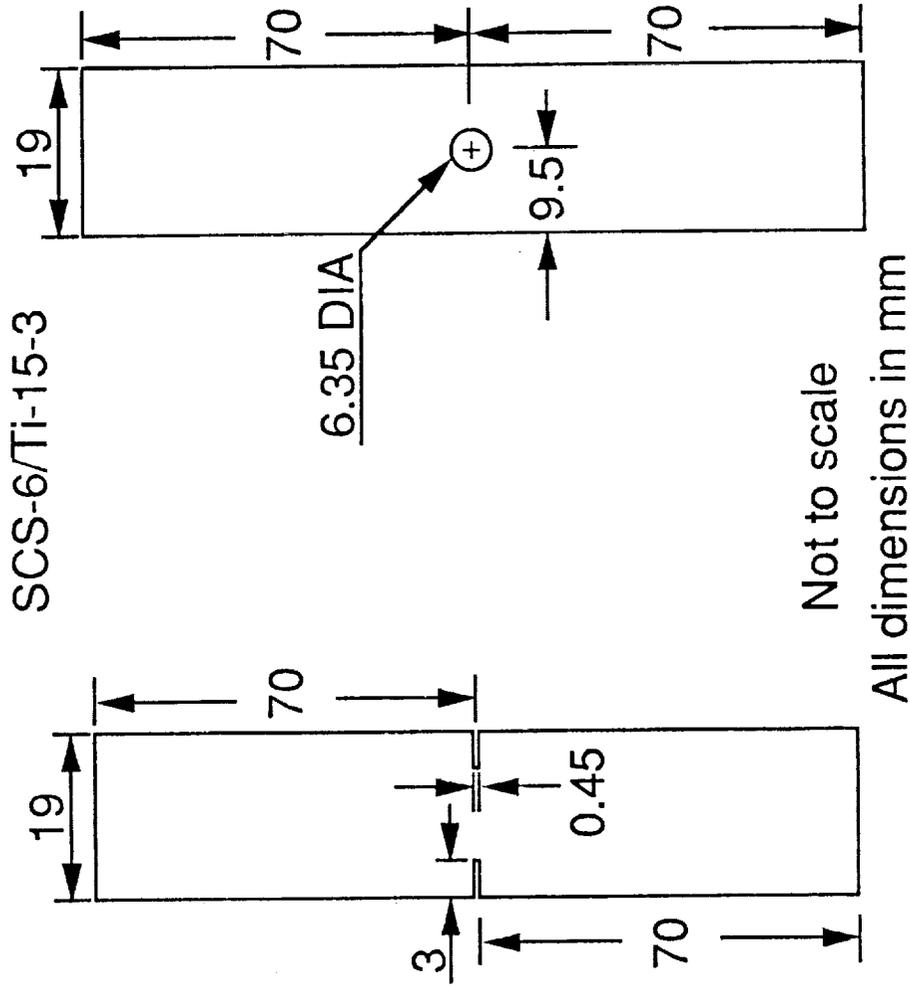
(a) Edge-notched specimen (b) Center-hole specimen

Figure 5.- Specimen configuration and dimensions.

All specimens were 19-mm wide and about 140-mm long and were cut using a diamond wheel saw. As shown in Fig. 5(a), the $[0]_8$ specimens were machined using electro-discharge machining with edge notches that were 0.45 mm thick and 3 mm long. The $[0/90]_{2s}$ and $[0/90/0]$ specimens had center holes that were machined using a diamond core drill and were 6.35 mm in diameter (Fig. 5(b)).

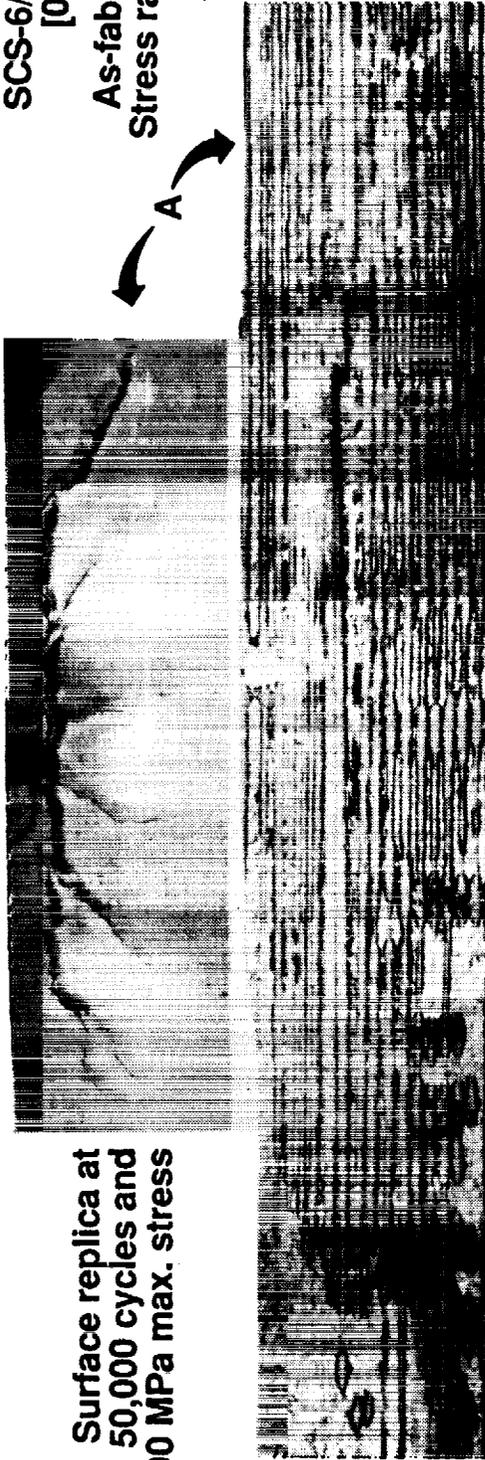
Surface replica at
50,000 cycles and
290 MPa max. stress

Etched surface
layer showing
fibers underneath

Figure 8.- Surface replicas and etched surface layer for ASF [0]₈ specimen.

In order to ascertain whether fiber failure was associated with the surface cracking seen in figure 7, some specimens were treated with hydrofluoric acid after testing. This treatment dissolved the titanium from the surface. The acid first seeped into the surface cracks and, thus, etched deeper in those regions where there were surface matrix cracks. This led to the fibers being more clearly visible in these regions. Such preferential etching of the surface layer allowed to preserve the original cracking pattern, to some extent, while exposing the fibers directly beneath the surface cracks. Figure 8 shows micrographs of an acid-etched specimen along with photographs of replicas showing corresponding surface damage. All of the fibers underneath the surface cracks appear to be intact. The absence of fiber failure was also confirmed by the radiographs.

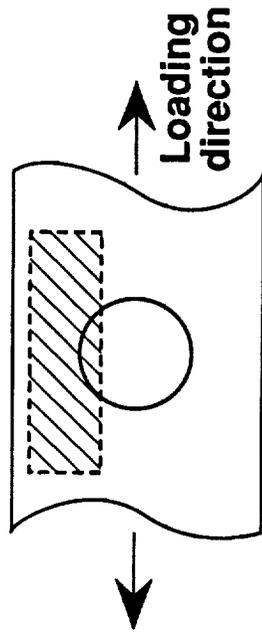
Max. stress = 150 MPa
50,000 cycles
R = 0.1

Figure 11.- Surface damage for center hole ASF [0/90]_{2s} specimen.

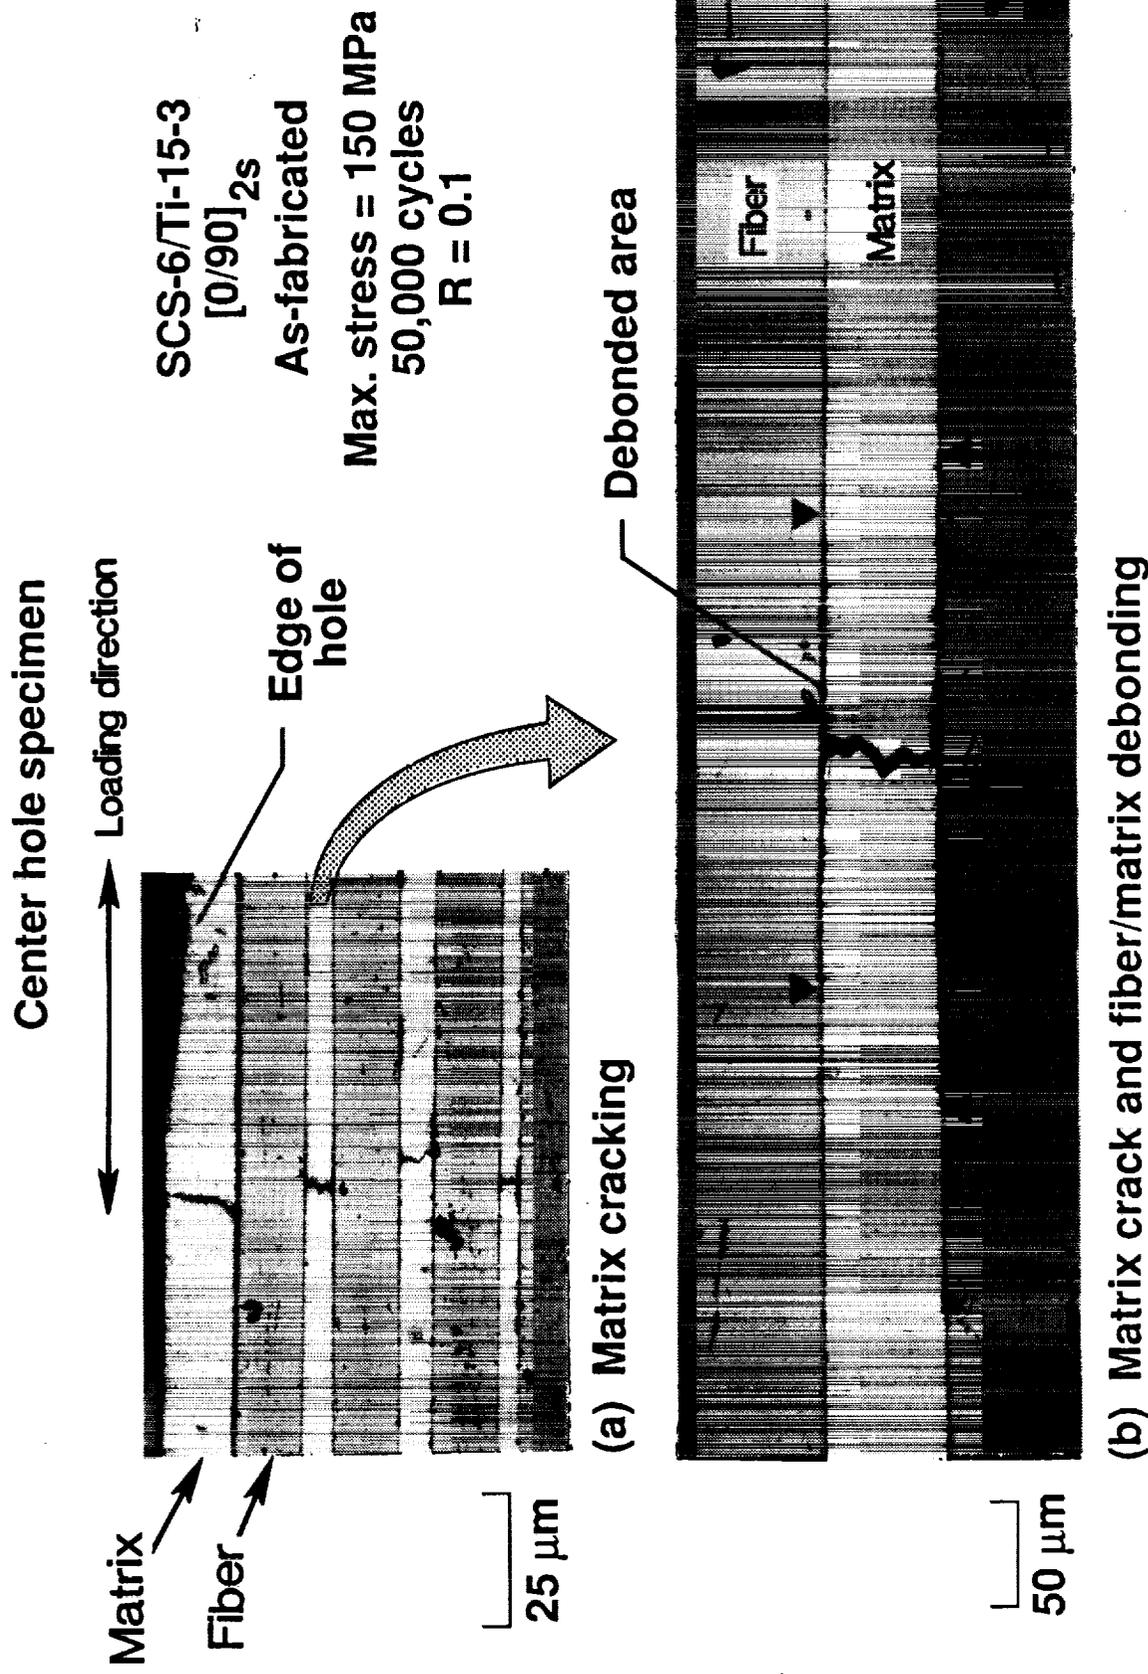
Figure 12.- Damage in 0 degree ply of [0/90]_{2s} ASF specimen with center hole.

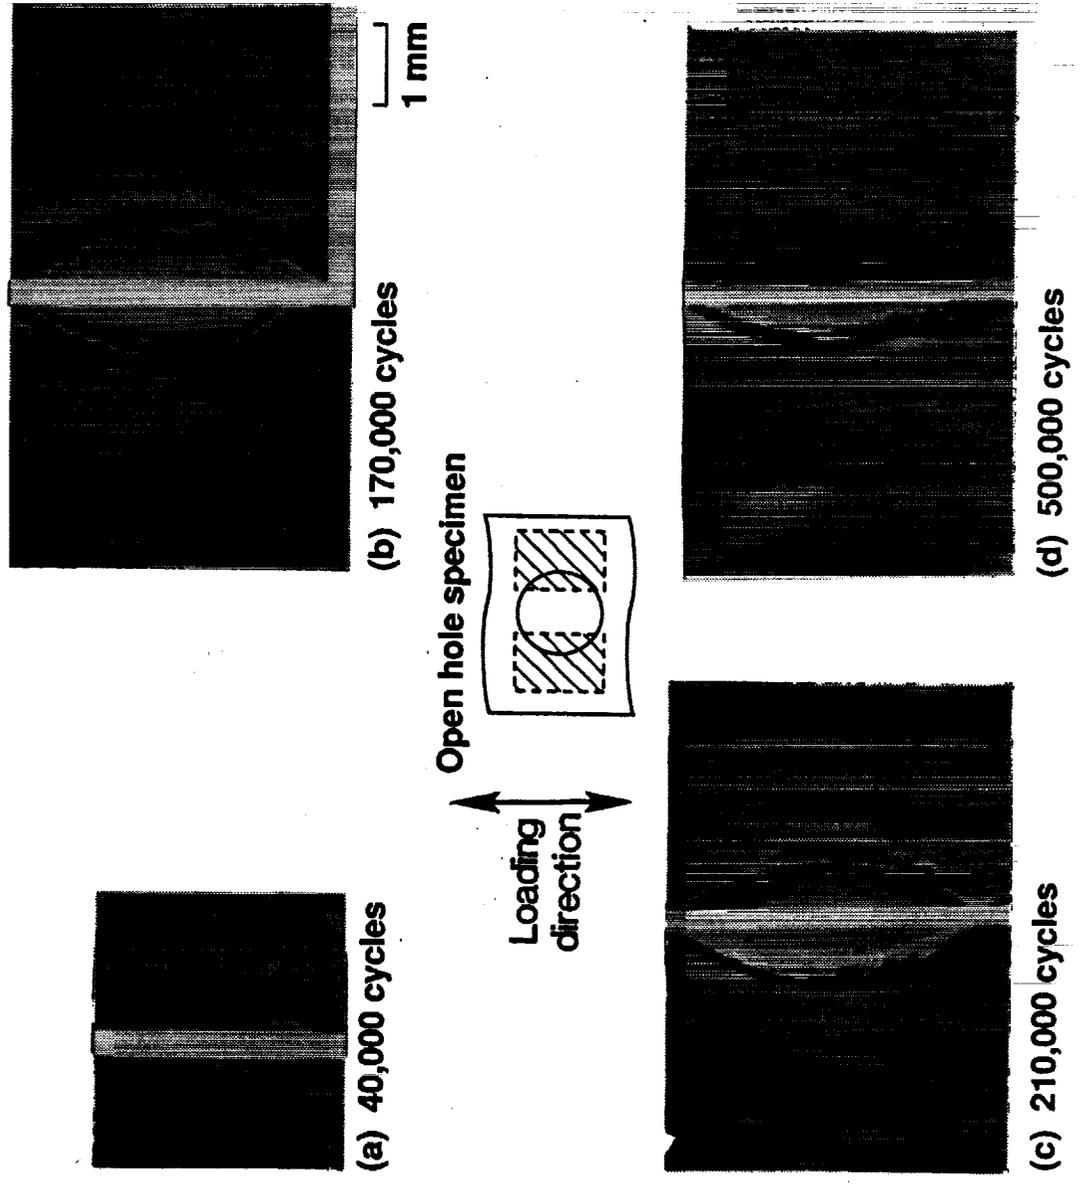
Figure 14. - Surface replicas of damage growth in [0/90/0] SPF/DB specimen.

Figure 14 shows fatigue damage growth for the SPF/DB $[0/90/0]$ specimen. Multiple cracking around the hole boundary was observed as in

the ASF specimen. However, these cracks were straighter than those in the ASF specimen and showed no branching. Again, the clip gage readings showed only a 2.6 percent difference in the local stiffness (after 50,000 cycles), indicating a lack of fiber failure. This was confirmed by the radiographs and by etching away the surface layer of titanium.
